Report on Field Measurements and Assessment of the I-64 Kanawha River Bridge at Dunbar, West Virginia

Final Report

ATLSS Report No. 01-14

September 2001

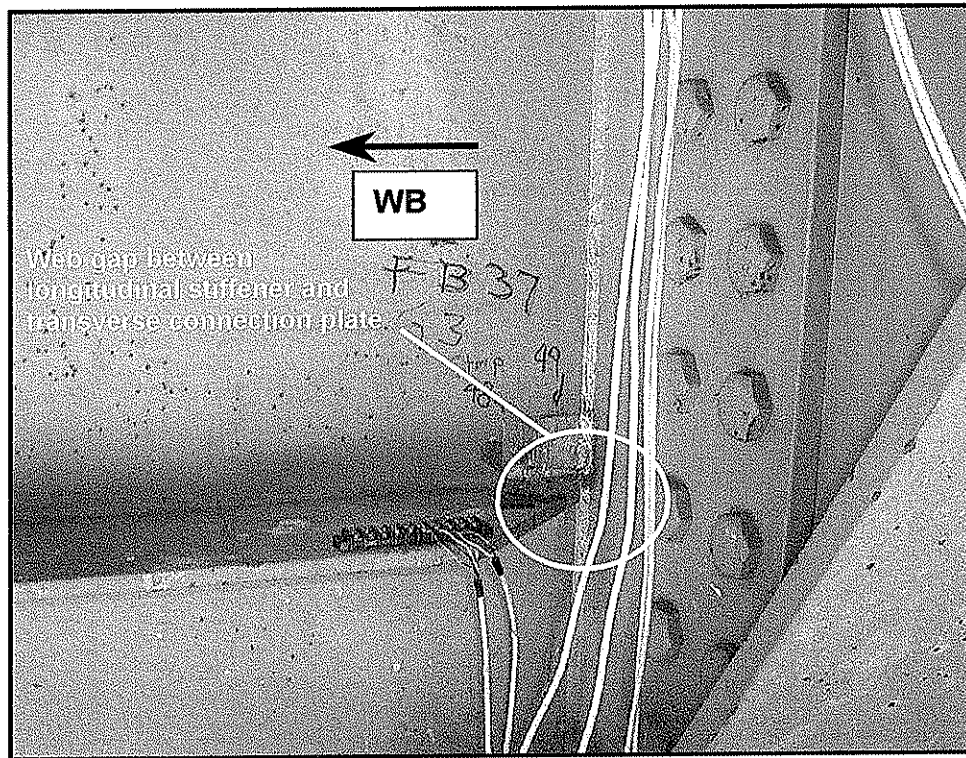
Weld terminations on longitudinal stiffeners are classified as Category E details (CAFL of 4.5 ksi) with respect to longitudinal or in-plane stresses. Gages were installed at two locations where longitudinal stiffeners terminated at the transverse connection plates.

Figure 4.5 - Location of web gap between longitudinal stiffener termination and transverse connection plate

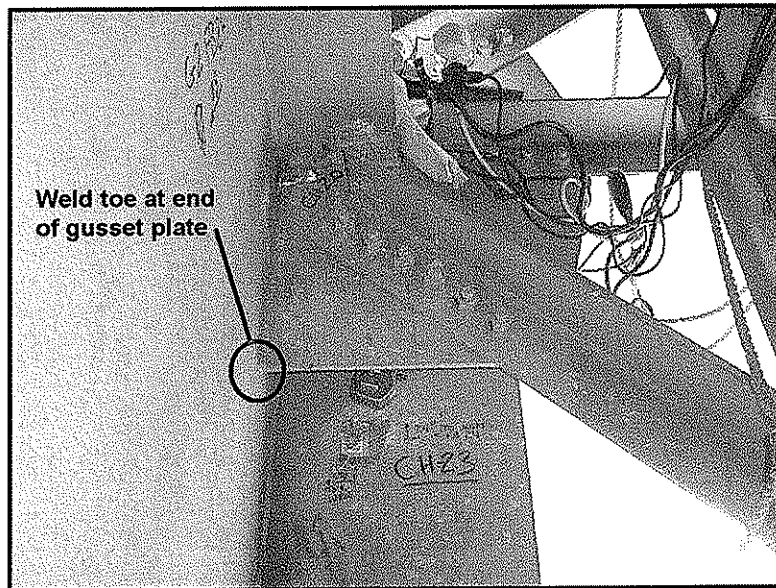
According to Eq. 4.2 and 4.3, the stress range in the web at the gusset plate is nearly equal to the stress range at the top of the bottom flange. It will therefore be conservatively assumed that the stress range at the gusset plates is equal to the stress range measured at gages installed at the bottom flange. A review of Table 4.1 indicates that the test truck would not produce any fatigue cracking at the weld termination due to in-plane stresses at this detail. The effects of out-of-plane displacements at the “free” edges of the gusset plate (as shown in Figure 4.6a) are not expected to be as great as the stress measured at the web gaps at the transverse connection plates. Because the web is flexible at the ends of the gusset plate, high stresses, like those developed in small web gaps, will not occur.

Figure 4.6a – Photograph of longitudinal weld termination at “free” end of gusset plate
Note the length of web that is available to accommodate out-of-plane displacement

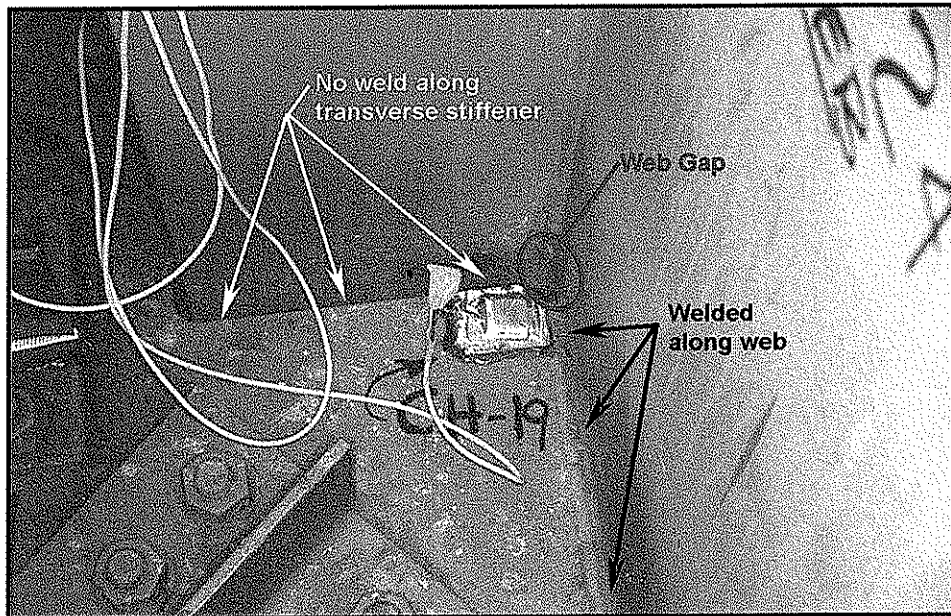
At several locations, gusset plates are attached to the web of the girder but not to the transverse connection plate as shown in Figure 4.9. Cracking has been observed in the web gap between the gusset plate and the transverse connection plate at a few floorbeams, particularly in the end spans.

Figure 4.9 - Photographs showing a detail in which the gusset plate is attached to the web but not the gusset plate. Note the location where web gap cracking typically occurs.

At details where there was no effective restraint provided, cracking is more likely to develop (i.e., floorbeams FB2 to FB6 and FB36 to FB40). In order to isolate the web gap region on each side of the transverse connection plates and arrest any potential cracks which may form, holes have been drilled as a retrofit at these locations as shown in Figure 4.10. If cracking does develop, it will grow into the holes and be arrested. Small segments of light angles have also been installed to provide a positive attachment between the gusset plate and transverse stiffener (See Figure 4.10). It is visually apparent from Figure 4.10 that only two bolts have been installed in the legs of the 3/8" angles.

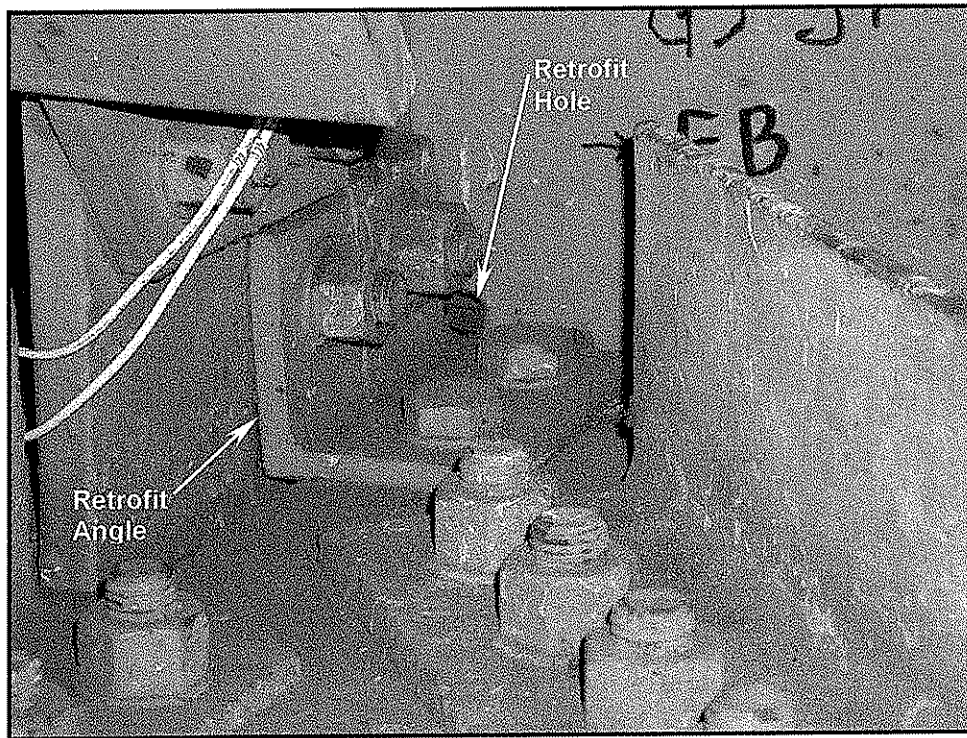
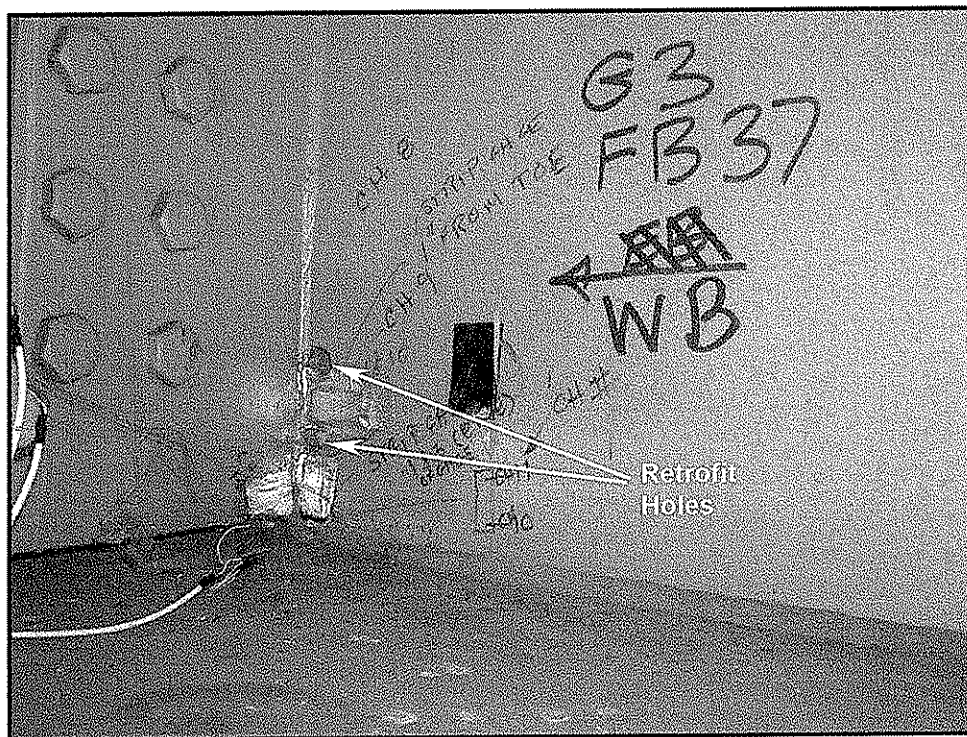
Figure 4.10 - Photographs of north and south faces of web at floorbeam 37 at girder G3.
 Note retrofit angles, drilled holes, and position of strain gages
 (the silver tape is installed to protect the gage from the environment)

Strain gages were installed on the opposite face of the web plate (CH_5, CH_6, CH_8, & CH_9) as this allowed complete access to the web gap region. Note that these gages are located between the two retrofit holes drilled above and below the gusset plate (see lower photograph in Figure 4.10 and Appendix A). Measurements made during the controlled load tests and the on-site monitoring indicated that the remaining "strip" of steel in the web will develop cracks in the future.

It must be noted that if the existing angles on the lateral gusset plate to transverse connection are replaced with a stiffer system, a more secure connection between the transverse connection plate and the gusset plate will be achieved. However, this will likely increase the stress range at the bottom web gap since most displacement will be

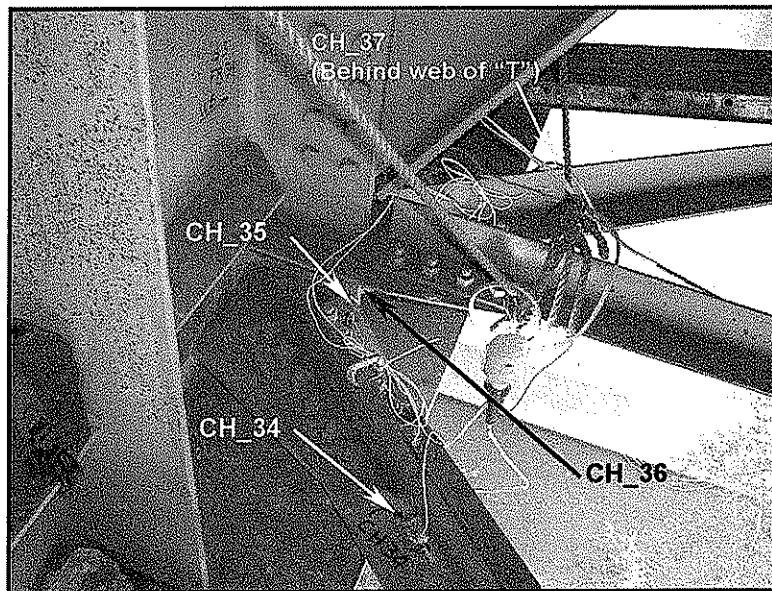
Figure 4.16 - Photograph of gages CH_34, CH_35, CH_36, and CH_37 installed at floorbeam 34 of G3 in bay 2

Channels CH_35 and CH_36 were installed perpendicular to the weld toe of the gusset to transverse connection plate welds at floorbeam 34 of girder G3, as shown in Figure 4.16. These gages can be used to establish if additional weld toe cracking can be expected at these details.

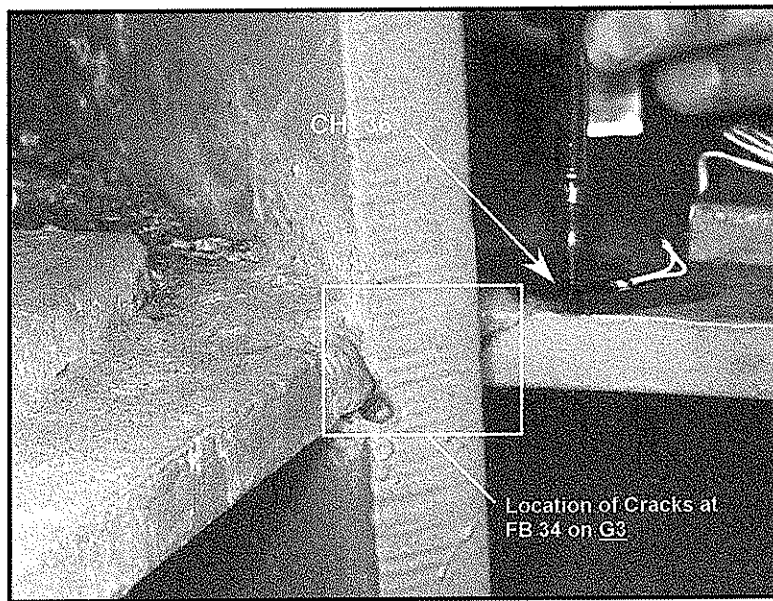
Small cracks were observed at the weld termination at the end of the of the gusset plate and the free edge of the transverse connection plate at floorbeams FB34 on girder G3 and FB8 of G3 [3]. A review of the inspection report [3] and photographs of the

detail, indicate that the cracks are most likely growing out of the lack of fusion zone on the lower side of the gusset plate. This cracking is shown in Figure 4.17. The single-bevel groove weld has a fillet weld placed at the root. A lack of fusion condition appears to exist at the plate edge. Depending on the size of the lack of fusion, cracks could be expected to grow at the plate edge into the welds at a lower stress range than from a weld toe. This appears to be the cause of the cracks observed at the gusset plates at floorbeams FB34 and FB 8.

Figure 4.17 - Close-up photograph of gage CH_36 installed at floorbeam FB34 of G3 in bay 2.

For weld toe cracking, the fatigue resistance of this detail can be categorized as category C for the cruciform type joint. The CAFL for category C is 10.0 ksi, which is

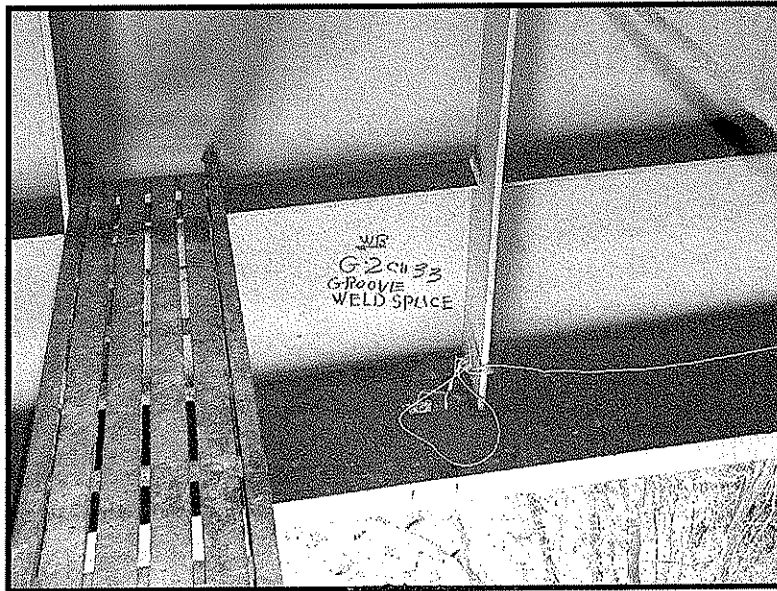
Even a 3/8 in circumscribed crack would be below the crack growth threshold at the maximum stress range of 4 ksi. No problems are expected at this apparent discontinuity.

Figure 4.20 - Photograph of channel CH_33 installed at an apparent weld discontinuity in a groove weld splice on the bottom flange of girder G2 between floorbeams FB32 and FB33

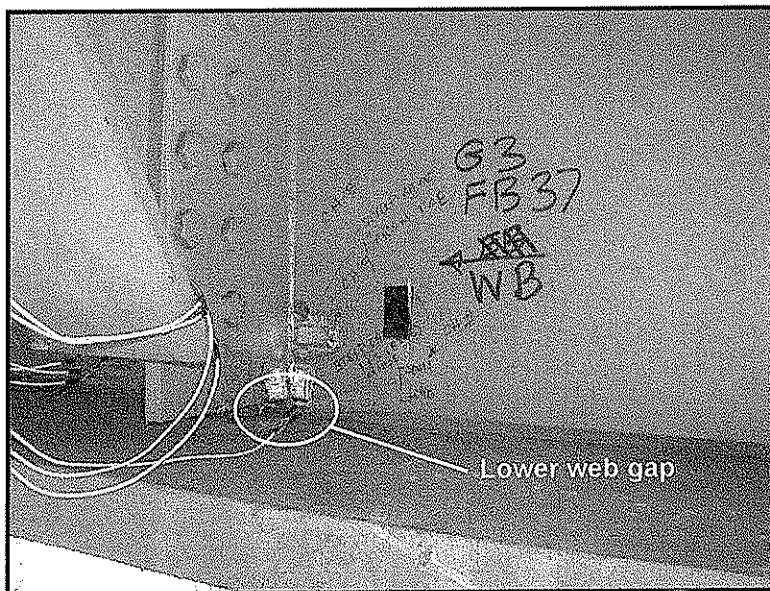
Figure 6.10 - Area susceptible to fatigue cracking after retrofit of connection between the gusset plate and transverse connection plate (opposite side of web shown for clarity)

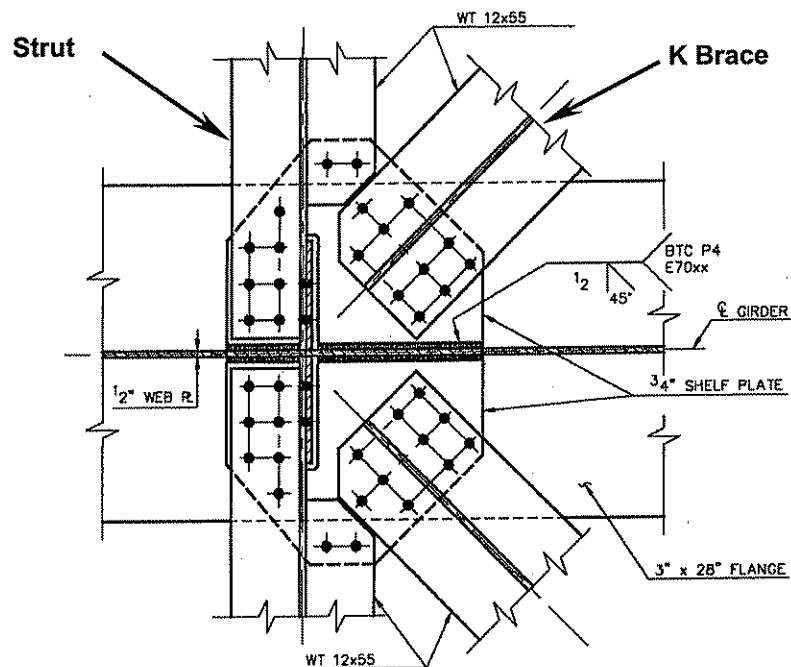
Figure 6.11 Gusset plate detail for interior girder used on failed span of Hoan Bridge in Milwaukee Wisconsin

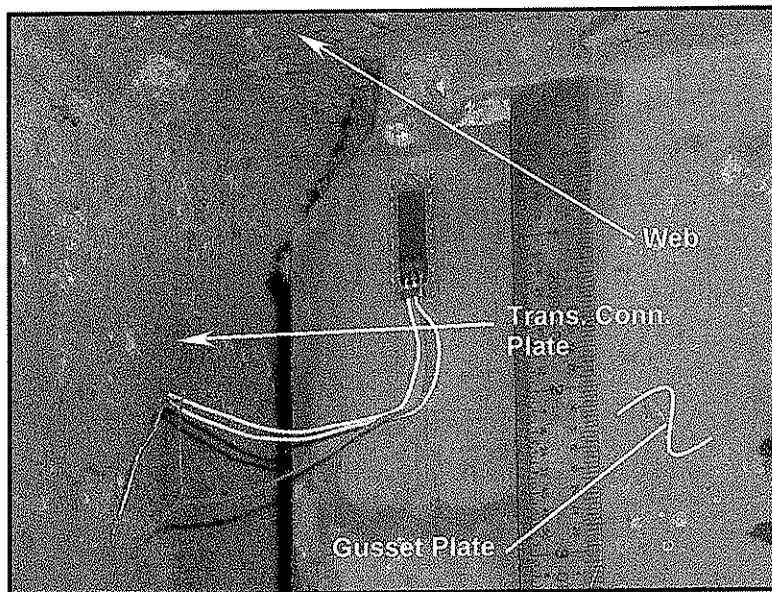
Figure 6.12 - Photograph showing gap between transverse connection plate and gusset plate as built on the Kanawha River Bridge
(Note snipe in gusset plate which increases web gap thereby decreasing stress in the gap)
